# No more crash accidents with divers or swimmers!

-- Crash accidents with a small vessels during diving and snorkeling --

Japan Transport Safety Board, Secretariat, Naha Office

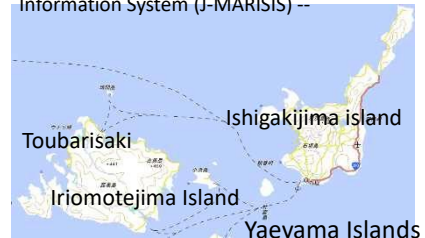
In June 2017, a passenger ship crashed into swimmers snorkeling in the area.

Summary: The captain was the only person onboard, and was sailing on the sea off the west shore of Toubarisaki, Iriomote, Okinawa Prefecture, on the way swimmers to pick up passengers and a tour guide, when his ship crashed into a snorkeling swimmer.

The swimmer was seriously injured, such as open wounds in the right forearm, fractures in the right shoulder blade and multiple fractured ribs.

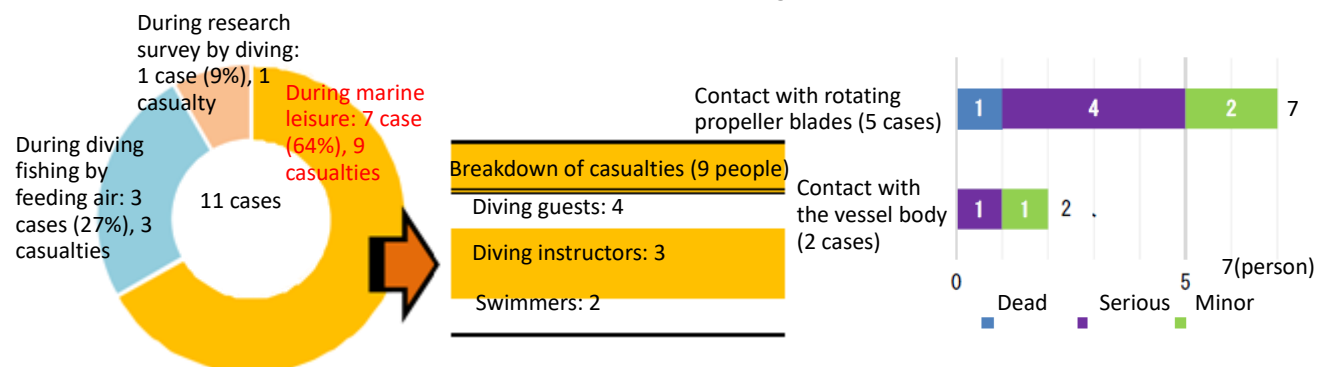
## Statistical information on the occurrence of crash accidents involving small vessels and divers or swimmers

There were 11 accidents which injured or killed divers or swimmers, and 7 of them occurred during marine leisure (9 casualties), which can be further classified by two direct causes: "contact with rotating propeller blades", and "contact with the vessel body". The former, "contact with propeller blades", causes serious injuries in most of the cases, and serious consequences such as death.

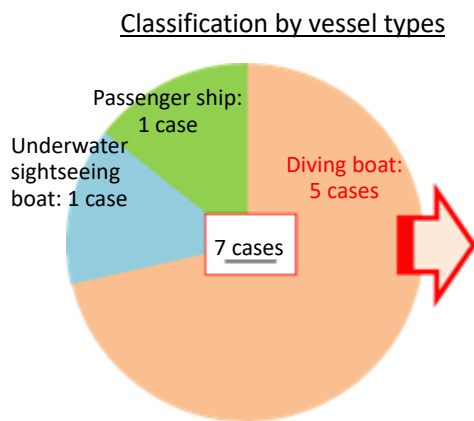
## Situations where diving boat accidents occurred

The 7 cases during marine leisure can be classified by vessel types, and diving boats are the most common, and 4 of them occurred when the boat moved backward.
